A study on helicopter main gearbox planetary bearing fault diagnosis

Zhou, L., Duan, F., Corsar, M., Elasha, F. & Mba, D.

Zhou, L, Duan, F, Corsar, M, Elasha, F & Mba, D 2019, 'A study on helicopter main gearbox planetary bearing fault diagnosis' *Applied Acoustics*, vol. 147, pp. 4-14.

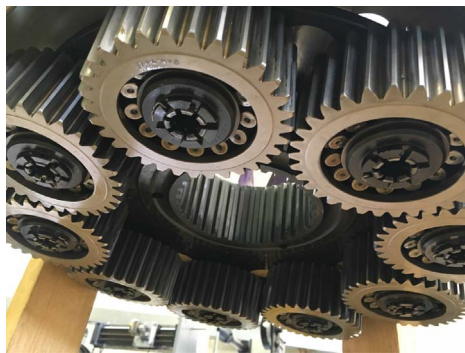
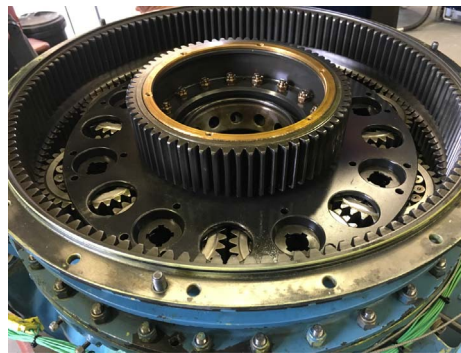
Fig. 2. MGB 2nd epicyclic module.

(a) 2nd Planetary gears/ bearings

(b) 2nd Epicyclic module ring and sun gears

To investigate planetary bearing fault diagnosis, defects were seeded on the outer race of the planetary bearing at 2nd epicyclic module in both test cases. Fig. 2(a) demonstrates 2nd epicyclic planetary bearings, which are driven by 2nd epicyclic sun gear and ring gear shown in Fig. 2b. Specifications of planetary bearings are documented in Table 2.

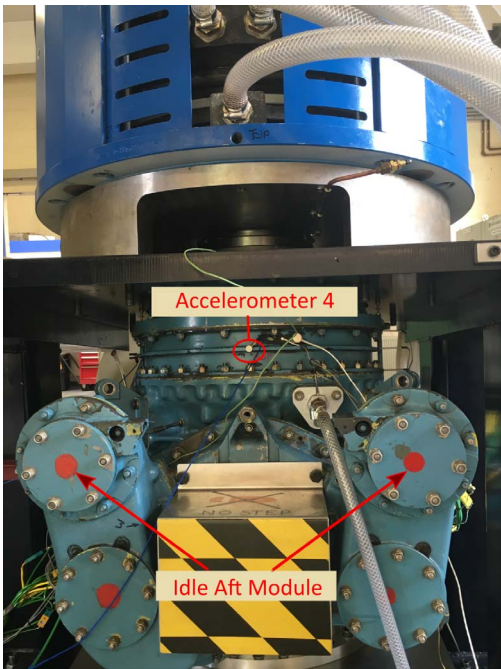
(a) Sensor installation side view

(b) Sensor installation front view

Fig. 5. Demonstration of accelerometers installation locations.

In this test case, 2 triaxial and 2 uniaxial accelerometers were installed to capture MGB's vibration information. Originally, accelerometers with 100 mV/g high measuring sensitivity and 50 g measuring range were selected. However, preliminary test results showed that the amplitude of recorded vibration can reach approximately 500 g, which saturated the high sensitivity accelerometers. Therefore, uniaxial accelerometers PCB 352C03 and triaxial accelerometers PCB 356A43 were selected, which have 10 mV/g sensitivity and 500 g measuring range. All accelerometers were mounted at the MGB case externally.

The rules of placing sensors are platform/mission specific [17]. Generally, sensors should be installed as close as practical to the components they are intended to monitor, while not affecting mechanical structures of the components [18]. Fig. 5 shows the installation locations of the accelerometers. Two triaxial accelerometers were allocated to monitor epicyclic modules and input shaft (accelerometer 1 and 2, respectively). Other two uniaxial accelerometers were installed in the middle of the two epicyclic modules to provide comparative information. Table 3 describes above installation arrangements.

Vibration data collected under healthy, minor seeded defect and major seeded defect conditions was processed. The MGB was operated at 16,000 rpm input speed with 180 kW load. The data from triaxial accelerometer 1 in Fig. 5 was selected. This decision was made considering that accelerometer 1 has the shortest relative distance to the seeded defect, therefore defect signal was less attenuated during transmission. In addition, according to the report of G-REDL accident [33], using data from sensors which were not attached near 2nd epicyclic module may have contributed to the invalid diagnosis of 2nd planetary bearing defect in that accident. Hence data from accelerometer 1 was considered most relevant to identification of the seeded defect.

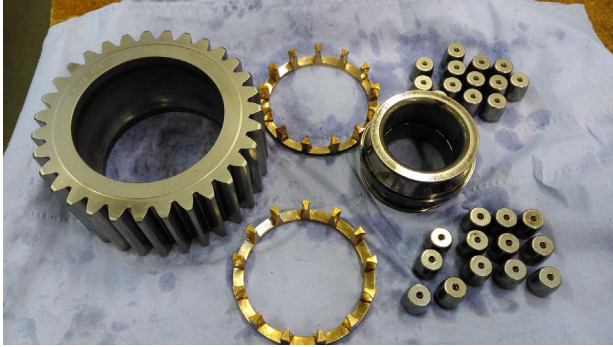
Fig. 6. The components of 2nd planetary bearing.

on the outer race of 2nd epicyclic planetary bearing, a 2nd epicyclic planetary bearing was disassembled (Fig. 6). The bearing had two layers of races, as well as two sets of rollers and cages.

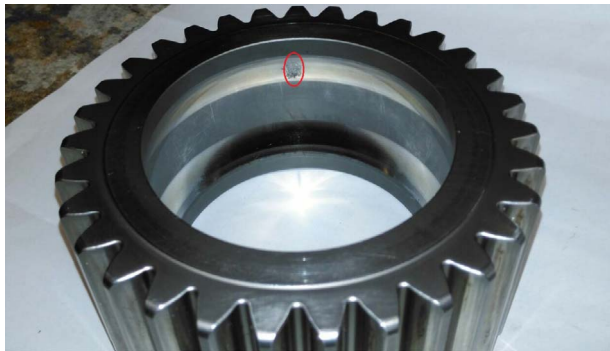
(a) Minor Defect

(b) Major Defect

Fig. 7. Demonstration of seeded defects in test case 1.

defect condition. The dimensions of seeded defects are detailed in Table 4. Pictures of minor and major defects are presented in Fig. 7. As introduced in Section 2.2.1, the maximum speed from speed-increasing gearbox to MGB was limited to 17,842 rpm. To comply with safety protocols, the maximum load and input speed in all test conditions were limited to 180 kW and 16,000 rpm respectively. Between each test, the MGB was stripped for 3 days to allow swapping the faulty bearing. Vibration data was recorded using NI 9234 data acquisition card and sampled at 25.6 kHz frequency.
